CASE HISTORY VINEYARD DRAINAGE - IDROSAC-MONTALCINO (SIENA)

1 - Description of the soil protection measures

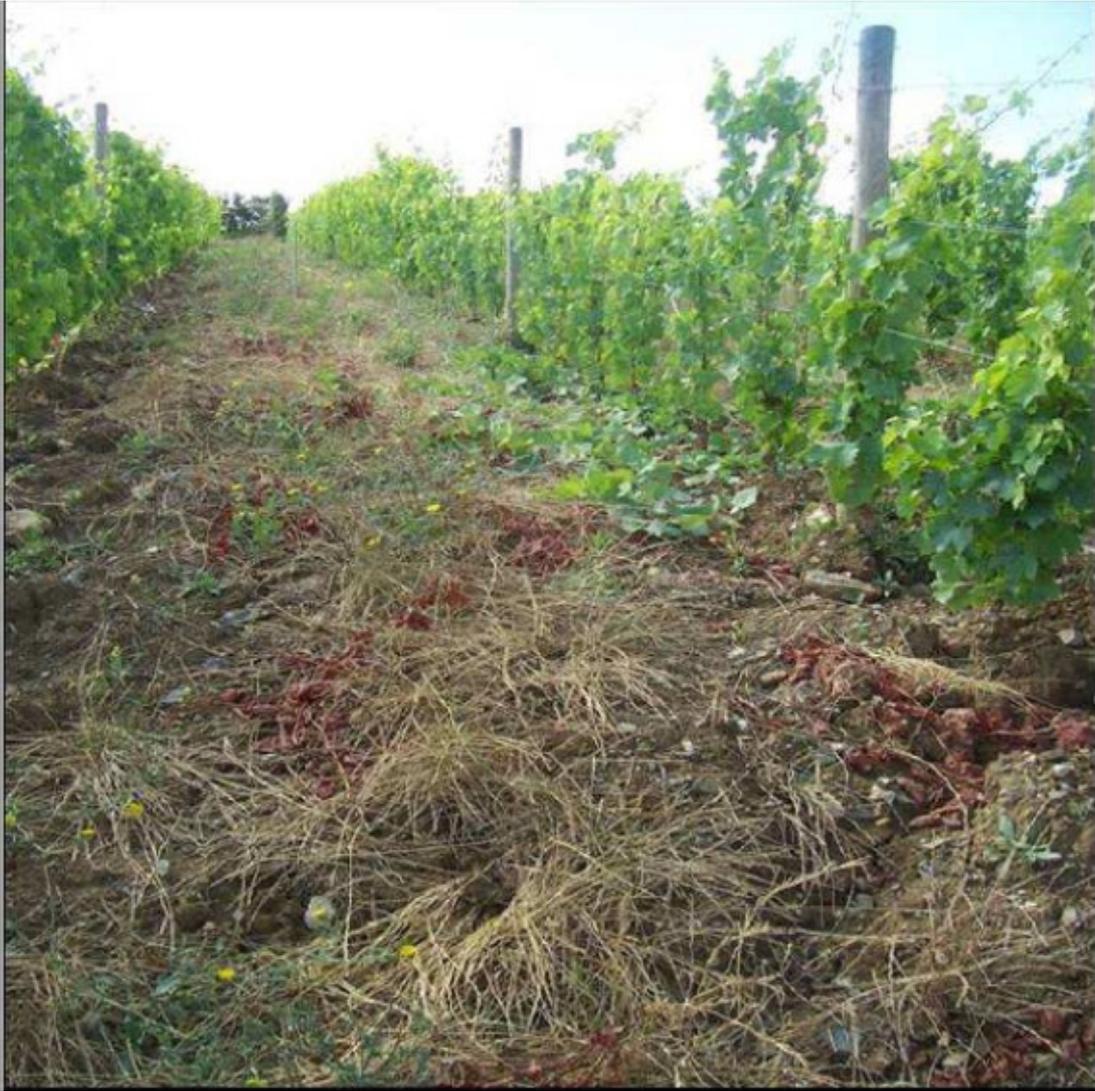
Figure 1 – Ground movements that destabilised the vineyard.

The purpose of the intervention is to create a shallow trench drainage system using the IDROSAC 500 system. Specifically, it is necessary to drain excess water at the contact point between the schistose clay and the fill soil in order to stabilise the movement occurring in the central portion of the vineyard, which has caused instability and damage to the new plant (Figure 1). From the information gathered from the owners and those involved in the work, it appears that the area in question has always been used for agriculture, with crops grown for the wine sector, and that drainage is of primary importance in order to remove excess water from the soil to improve its use and safeguard the growth of the plants, with a consequent increase in agricultural production and speeding up of agricultural operations. It should be noted that vines clearly suffer from excess moisture in the soil; interventions that allow rapid disposal of excess water reduce and/or prevent erosion and at the same time create a subsoil environment that is more suitable for root activity. For hilly terrain, it is therefore a priority to sow and/or maintain grass cover, which prevents surface water runoff and the transport of soil particles, as well as to install underground drainage systems to reduce unproductive areas. The IDROSAC 500 system (Figure 2) was chosen both for the lightness and versatility of the material and for the logistics of the intervention area, which had to be minimally invasive in order to preserve the condition of the vines and not damage the end posts, columns, rows, etc.

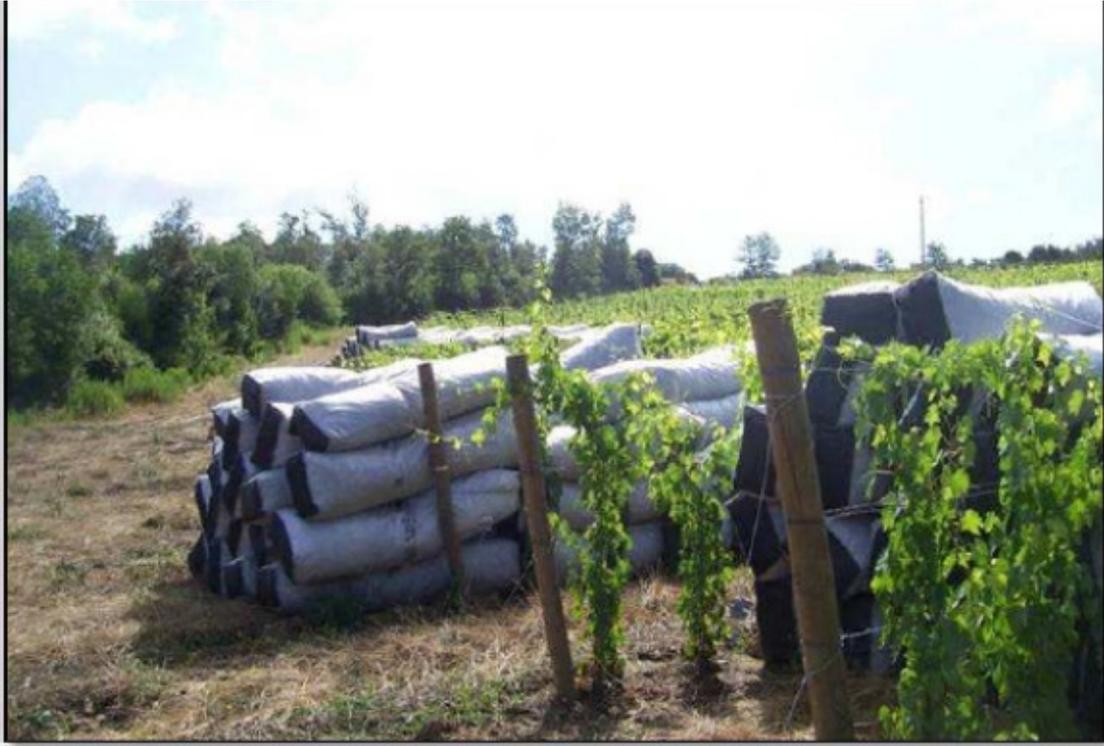
Figure 2 – Flexible non-woven drainage bags, model IDROSAC 500, used

As a result, IDROSAC flexible bags proved to be easily transportable by hand along the rows, unlike wheelbarrows filled with gravel and/or PVC pipes, which would have required considerably more care, time and effort.

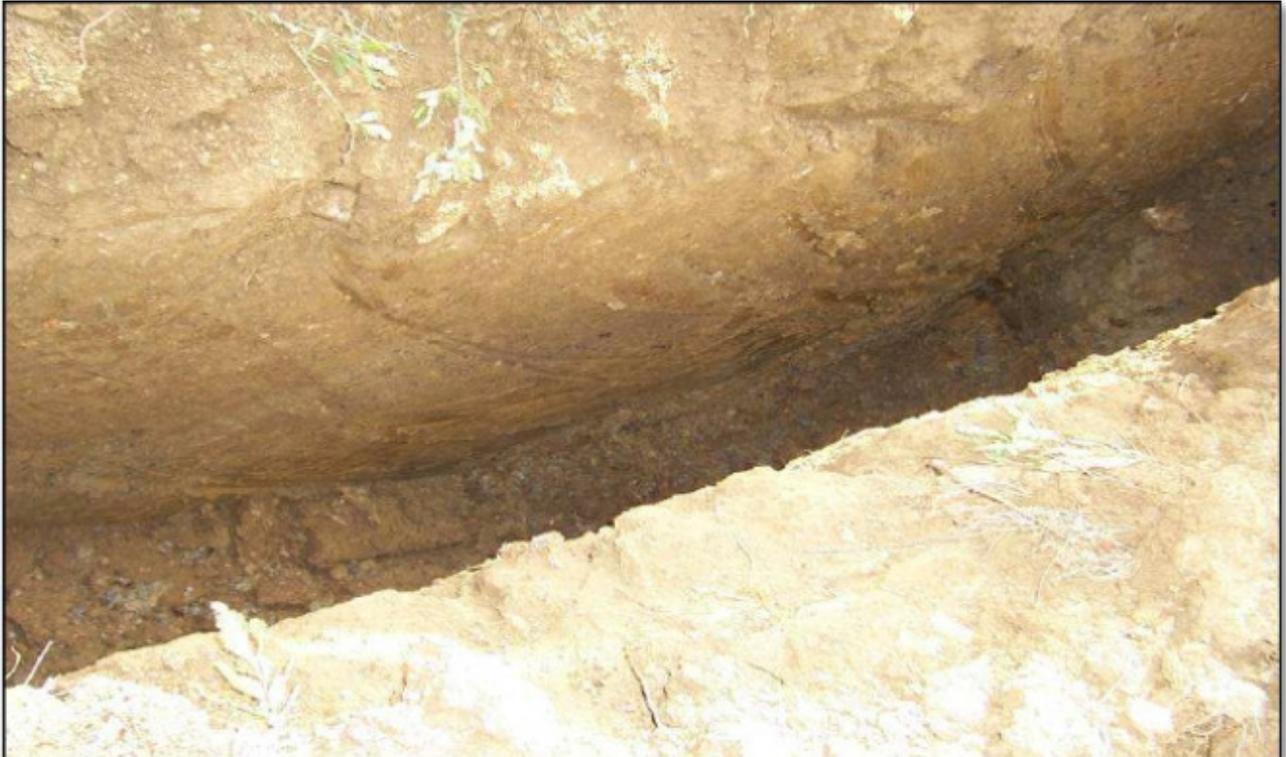
Figure 3 - Excavation carried out with a mechanical excavator for the installation of the IDROSAC 500 system at the Montalcino estate (SI).

The first phase of the work was the excavation using a mechanical excavator equipped with a universal excavator bucket (Figure 3). Taking into account the above, the excavation operation was carried out with minimal earthworks in order to preserve the crops from damage. Based on the exploratory test carried out with the excavator and taking into account the client's operational requirements (at least 1 m of lateral clearance from the rows of vines to ensure future vineyard operations), the Project Manager (PM) deemed it possible to excavate an area of separation close to one and a half metres. It was therefore decided to excavate between the rows (18 in total) with a 40 cm bucket until reaching the vineyard slope downstream, so that the drained water would flow outside the unstable area. To facilitate the subsequent installation of the drainage bags, it was recommended to take care in profiling the walls of the excavation and to finish the bottom of the excavation so that it was as flat and horizontal as possible and as undisturbed as possible.

No support works were necessary for the excavation as it was stable, being set on compact clayey lithologies at a maximum height of 1.5 m from the ground level.

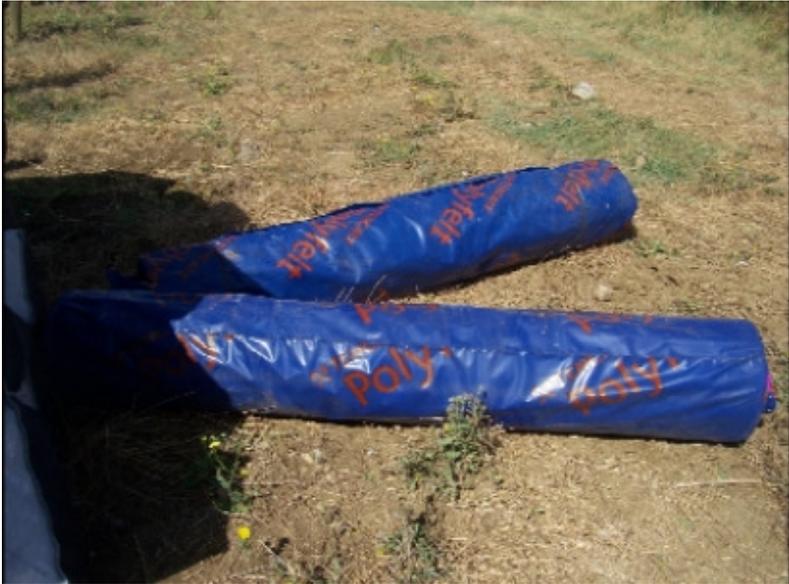
Figure 4 – Pieces of non-woven geotextile (TNT) used to cover the IDROSAC 500 drainage bags at the estate in Montalcino

The DL deemed it appropriate to use a layer of geotextile (Figure 4) of the non-woven fabric (TNT) 2 m wide as a cover for the IDROSAC 500 drainage bags.

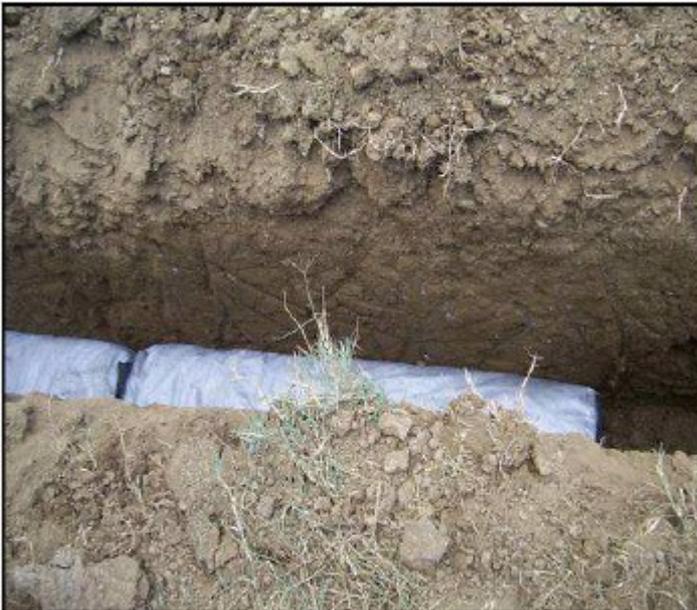
Figure 5 – Positioning of IDROSAC 500 drainage bags at the bottom of the trench

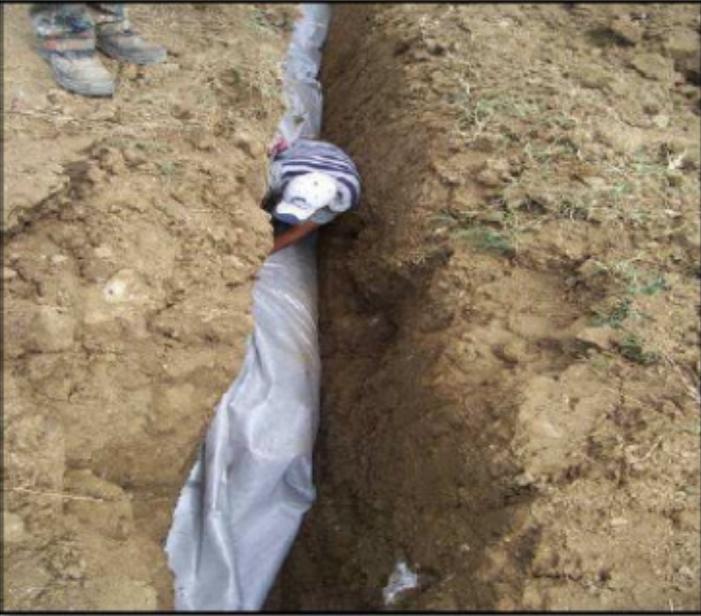
Figure 6 – Manual covering of the drainage bags with TNT inside the trench

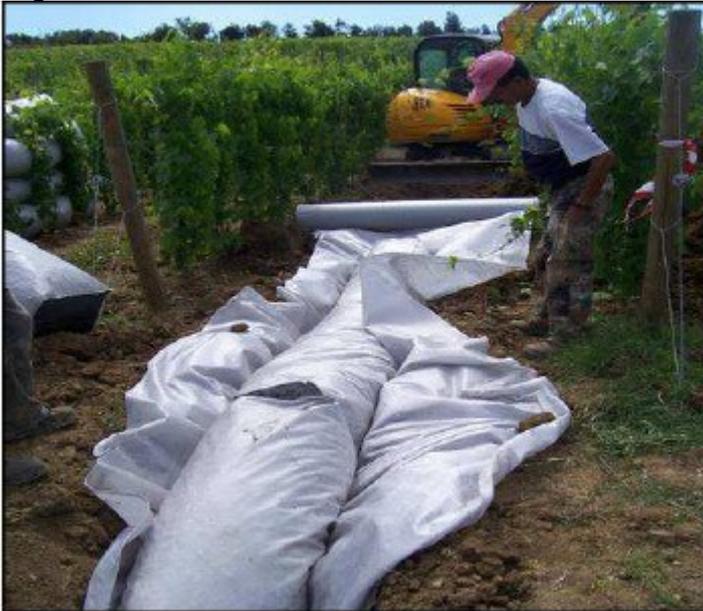
Figure 7 – Laying the TNT piece lengthwise with respect to the direction of the excavation

The DL decided on a laying system along the excavation line (Figure 7 drainage bags). Once the drainage bags had been laid, the non-woven fabric was manually closed over the bag itself (Figure 8).

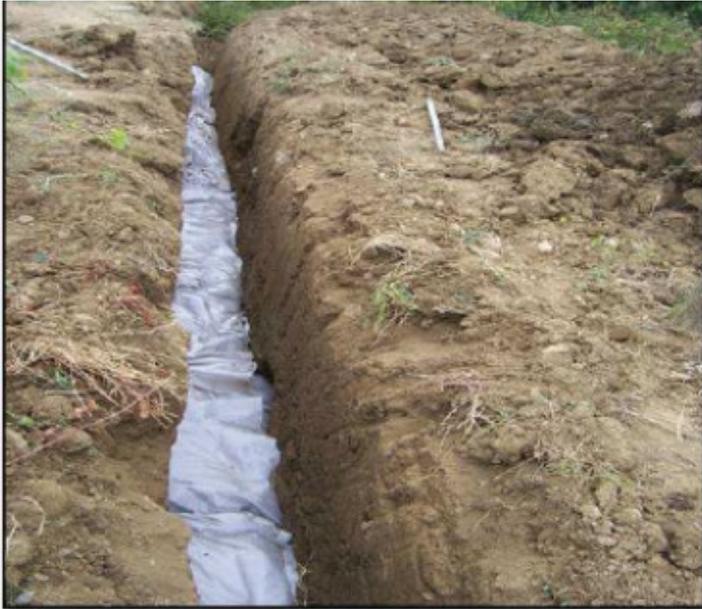
Figure 8 – Manual closure of the non-woven fabric over the IDROSAC 500 drainage bag
